## Eavestroughs & Downspouts

**Pure Spirits Complex under wraps during blizzards and record cold spells**

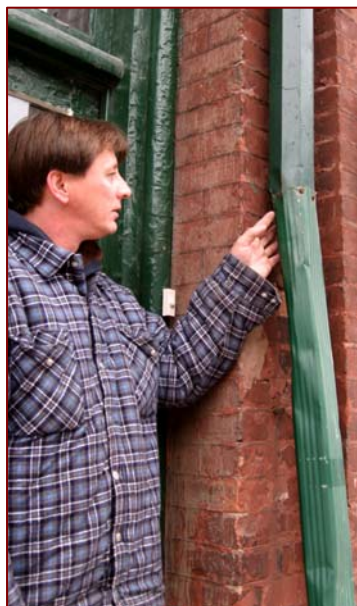
In the intervening years, much has changed. Not only has time weathered the original materials, but new materials and methods were used at various times to repair or alter the building. For example, sections of copper downspouts were replaced with cheap aluminum spouts that are less sturdy and, arguably, less attractive than the originals.

**Dented aluminum meets  
1870s copper**

At ground level, dented and unsightly aluminum downspouts were replaced with copper replicas matching the copper sections above; and ugly aluminum straps that had replaced the original fastening system were replaced by replicas of the original system. Rather than throwing straps around the outside of the pipes, the Victorian builders had attached downspouts to the building from behind the pipe, creating a streamlined profile. To reproduce this heritage effect, a dozen bronze “keys” had to be specially cast, plugged into the brick where old ones had broken off, and then attached to a ridge behind the pipes. And then everything was painted green, in line with earlier practice.
